Radar-Assisted Traffic Camera (TCS402) V4.5.0

Release Note

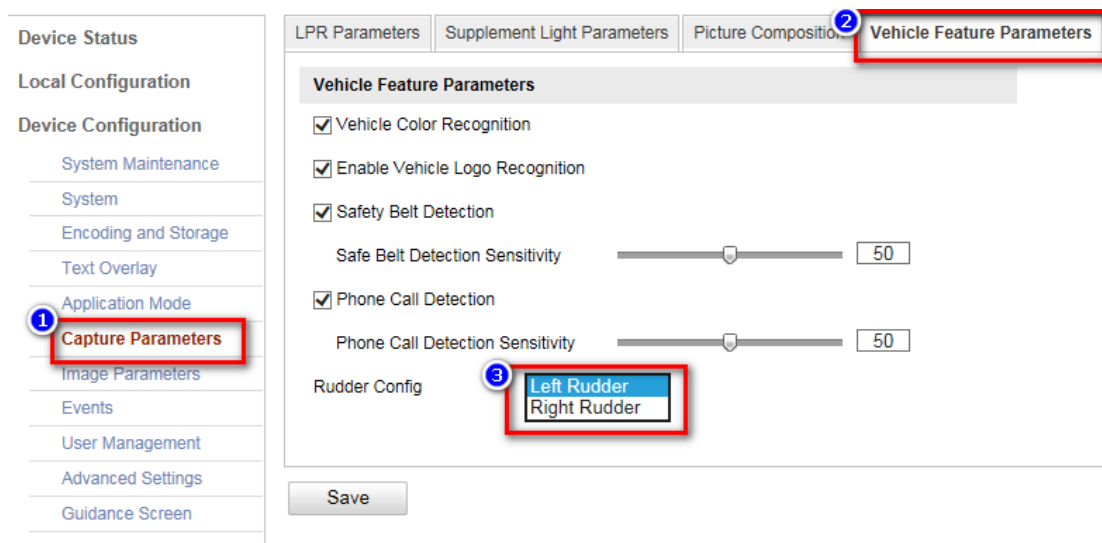
2.2.5. Modify the Rudder Configuration is the right rudder problem by default.
